Consolidated Metco ECSI # 3295
9:00 AM – October 19, 2006

Subject: Consolidated Metco, Inc. - Response to Strategy Recommendations
13940 North Rivergate Blvd., Portland, Oregon
DEQ/ECSI File No. 3295
K/J 036423.00

CONSOLIDATED METCO, INC.
RIVERGATE FACILITY
PORTLAND, OREGON

SITE PLAN SHOWING IMPACTED AREA

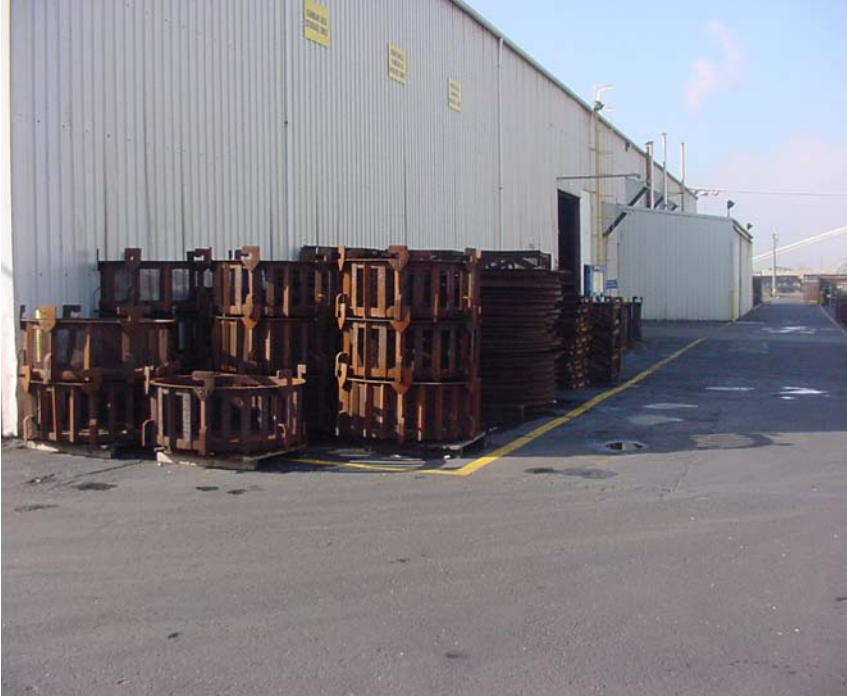
The referenced items are not drums or other storage vessels, but rather steel heat treating baskets that are used in the curing of aluminum-casted products. DEQ staff took a photograph of these baskets during their October 2003 Site visit. A copy of the photograph is attached as Photograph No. 1.

Photograph No. 1: Heat treating baskets.

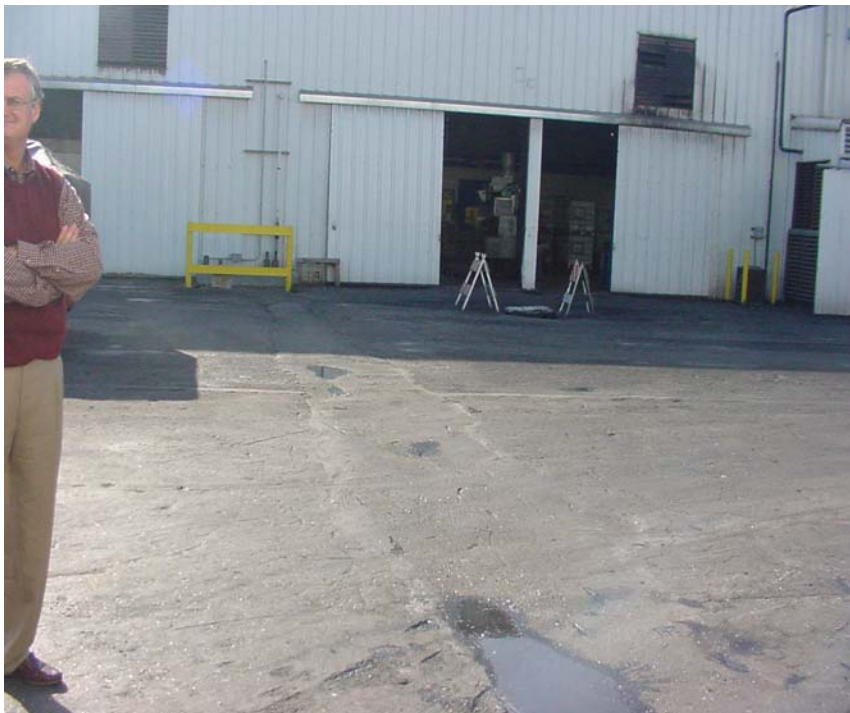
There is no evidence to support the statement that the soil profile between ground surface and 8 feet below ground surface (bgs) was saturated with released cutting fluid. It was determined through the course of the subsequent investigation, and as outlined in the 9 March 2001 Spill/Release Report submitted to DEQ by ConMet, that the source of the release originated from a small split in a connection where galvanized piping connects to the polyvinyl chloride (PVC) pipe that runs between the reclamation building and machine shop (Photograph No. 2). The galvanized - PVC pipe connection was located immediately south and outside of the

reclamation building at a depth of approximately 2 feet bgs, not 8 feet bgs as noted in the DEQ SSR submittal. The release appears to have traveled from the galvanized - PVC pipe connection through the gravel subgrade underlying the asphalt pavement and into the adjacent stormwater catch basin through a crack in the frame of the catch basin. The locations of the leak and the stormwater catch basin are shown in Photograph No. 3.

Photograph No. 2: View of reclaimed cutting fluid pipeline located between the reclamation building and machine shop.

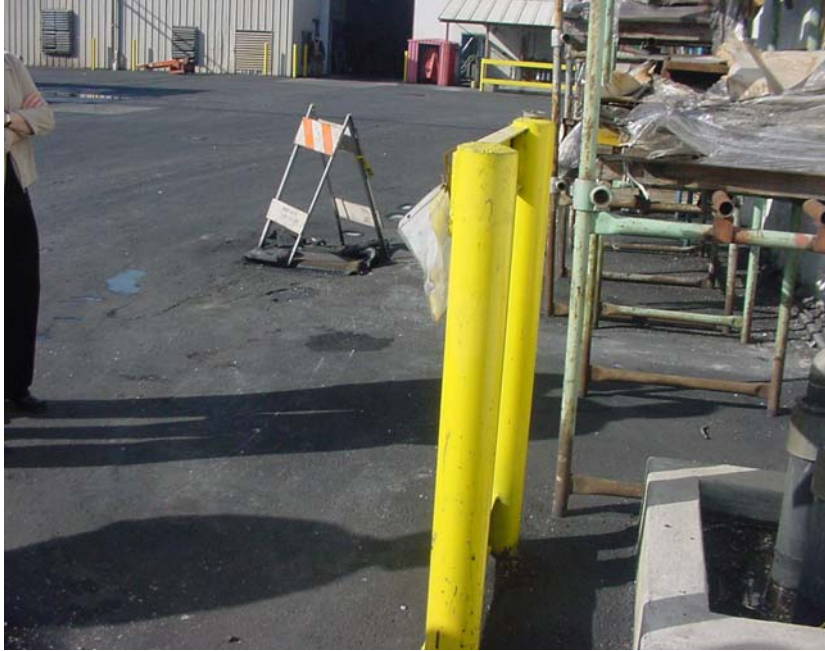
Photograph 3: View of February 2001 release area showing reclaimed cutting fluid pipe (in lower right) and location of the stormwater catch basin.

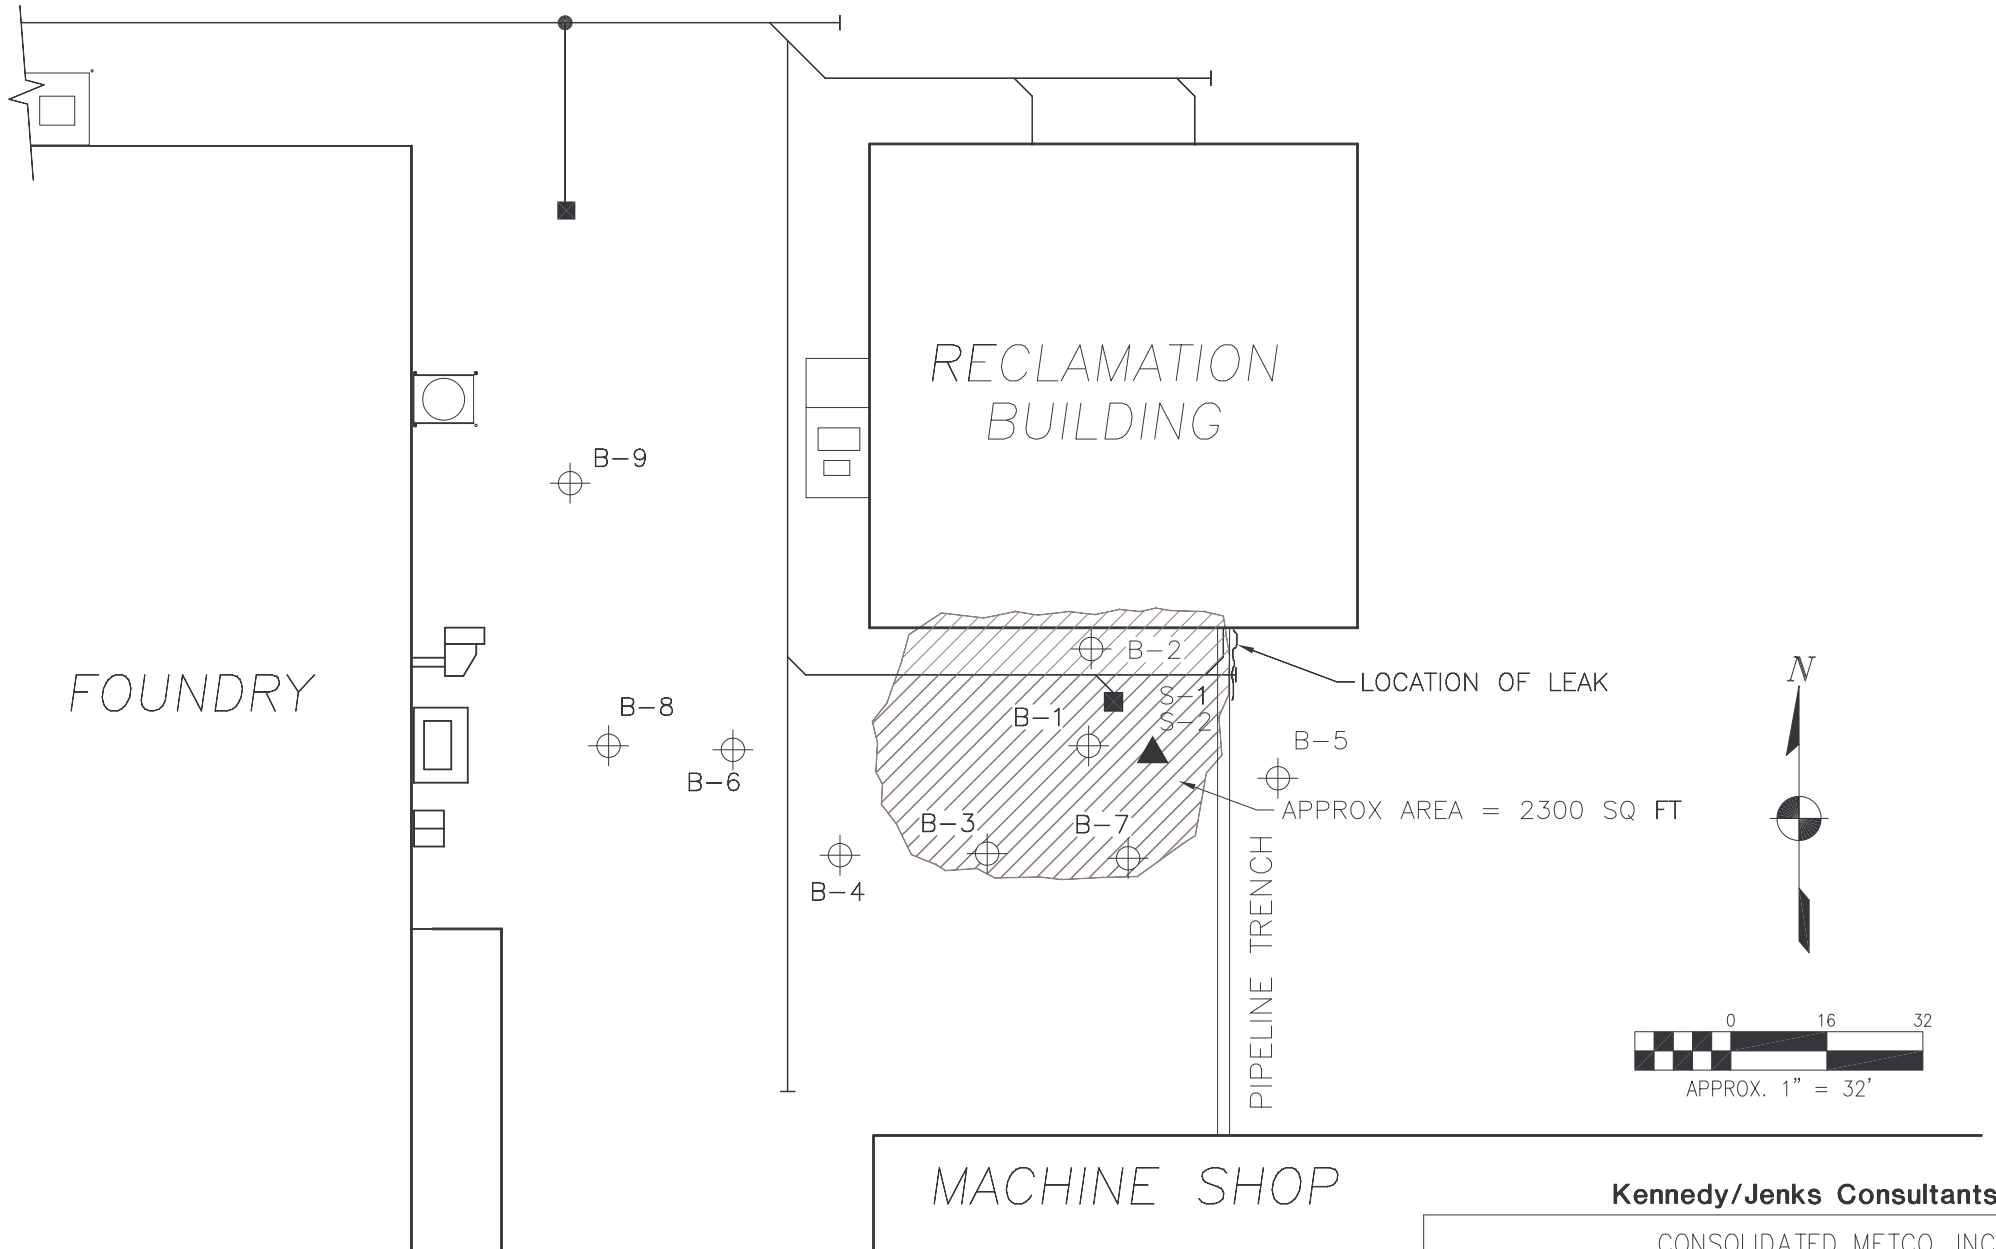
FIGURE 1

As referenced in the 10 May 2001 Environmental Sampling Report prepared by Kennedy/Jenks, several shallow hand-dug explorations were completed by ConMet in the vicinity of the cutting fluid pipeline to a depth of approximately 1.5 feet bgs. Cutting fluid and water were observed flowing into some of the hand-dug boreholes from the gravel subgrade immediately underlying the asphalt pavement. This "perched" cutting fluid/water appeared to be laterally discontinuous as it was not in all of the hand-dug explorations completed in the vicinity of the pipeline. Based on field observations and the results of analytical testing, the apparent extent of the reclaimed cutting fluid release is shown on the attached Figure 1.

There is evidence that the reclaimed cutting fluid did infiltrate fill materials immediately surrounding the cutting fluid recirculation pipes and the gravel subgrade in the immediate vicinity of the release location. However, the majority of impacted pipeline fill material (15.46 tons) was excavated by ConMet's contractor and transported offsite for disposal. The small volume of impacted subgrade material did not warrant removal, particularly considering its removal would have required tear out and replacement of the asphalt pavement cap in the release-impacted area (see Figure 1).
